Wildbach- und Lawinenverbau

Zeitschrift für Wildbach-, Lawinen-, Erosions- und Steinschlagschutz
Journal of Torrent, Avalanche, Landslide and Rock Fall Engineering

Study trip 2011 Iceland

ISBN: 978-3-9503089-2-1
75. Jahrgang, Dezember 2011, Heft Nr. 168

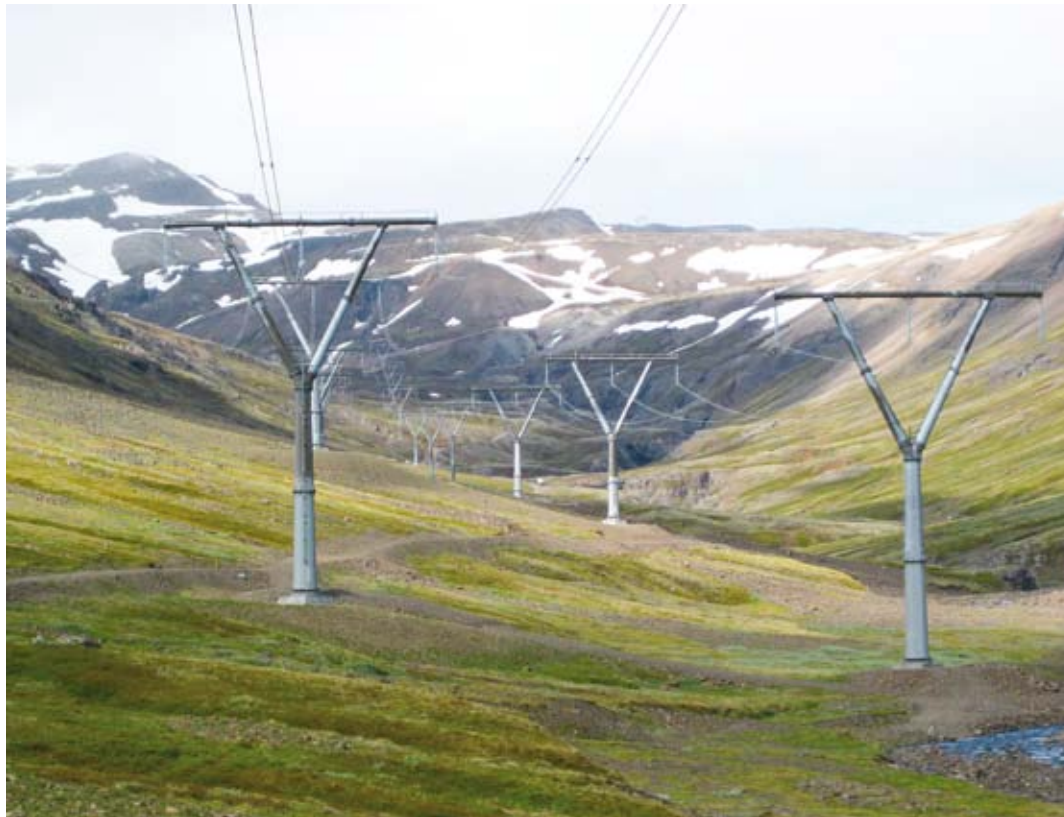
Fig. 2: Parallel transmission lines with avalanche towers

These 420 kV lines in north-eastern Iceland are the only source of electrical power to a large aluminium smelter located at the coast. The smelter uses bauxite, which comes by great container ships from Jamaica or Australia, to make aluminium.

Forty-four km of the two lines are parallel with a spacing distance of 60 metres. The total length of the lines between the aluminium smelter and the powerhouse of a hydropower

plant is around 50 km for each transmission line. The elevation of the line is between 20 and 620 metres above sea level.

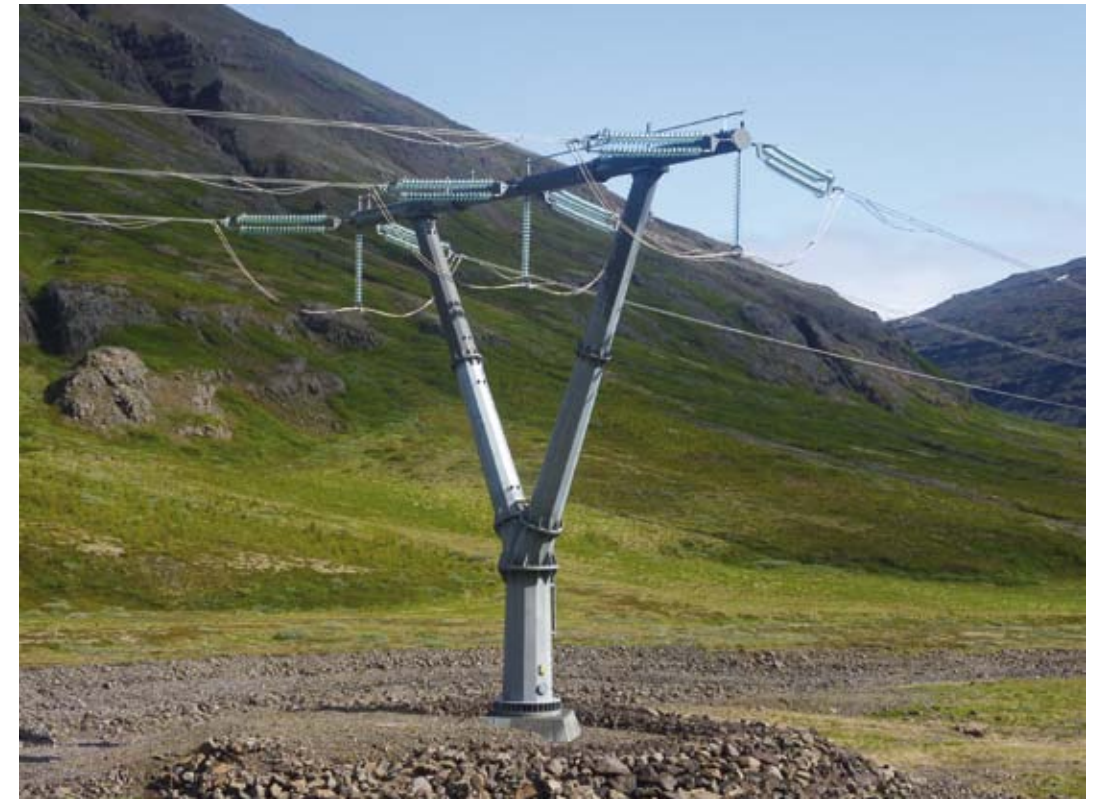
Fig. 3: "Y" type single pole tower.

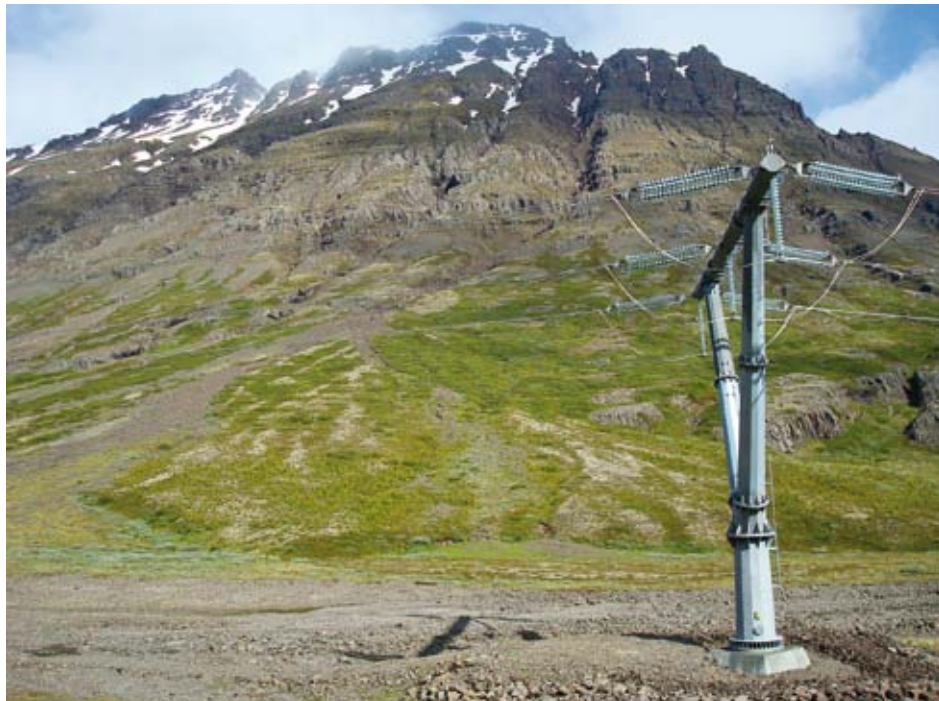
Fig. 4:
Tower in an
avalanche
path

To reduce the risk, two parallel transmission lines were built. The calculated exposure level for failure of both lines was, $P = 6.5 \cdot 10^{-4}$ ($T \approx 1500$ years).

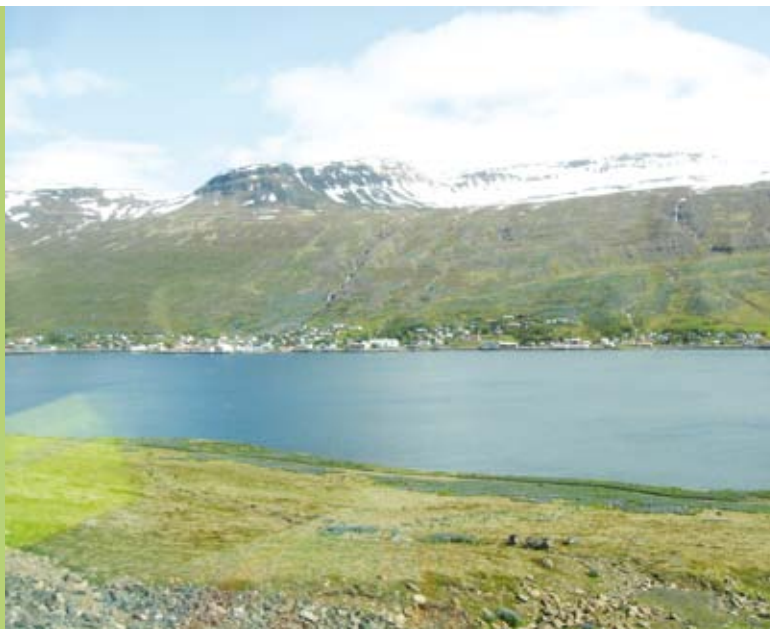
Fig. 5:
Eskifjörður
with several
gullies

The next short stop was in a little town in a fjord called Eskifjörður. This town with a small settlement near the seaside has some characteristic watercourses from the hillside straight to the sea, which flow down in small gullies. Four gullies go directly through

the small settlements. Along these gullies, several slush flows have caused accidents and damages to homes and infrastructures. A wet and thick snow layer in combination with precipitation

causes very spontaneous flows. Because of these accidents, a hazard map based on the Icelandic guidelines with three risk lines was also prepared for this area.

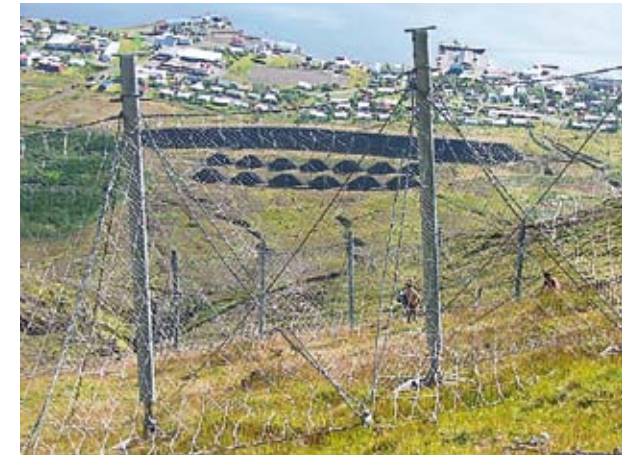
Fig. 6: Three types of defence structures; supporting structures, braking mounds, catching dam

Defence structures in the Drangagil area are of three types, supporting structures, braking mounds and a catching dam.

The supporting structures are located in the starting zone of Drangagil and include approximately 1000 m of 3.5-4.0 metre high avalanche nets.

The braking mounds are positioned in two rows above the residential area, a total of 13 mounds. The mounds have a steep front facing the mountain, are 10 metres high and each mound is approximately 10-12 metres wide at the top. The 400 metres long catching dam is located

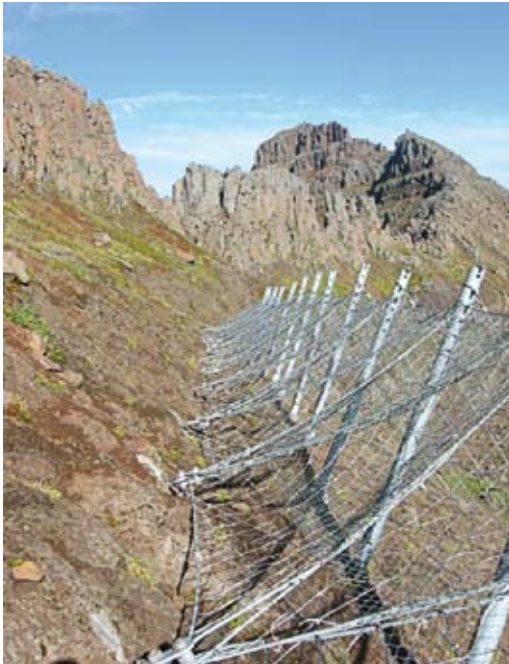
Fig. 7: Supporting structures: type ISOFER ©

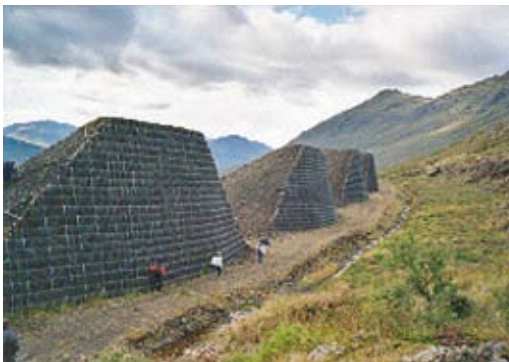
Fig. 8: Braking mounds with 76° steep face, constructed in reinforced earth technology

at a distance of 100 metres from the residential area. The dam is 17 metres high with a steep front facing the mountain. The total volume of earth fill comprising the catching dam and the braking mounds is approximately 260,000 m³. The steep dam fronts facing the mountain are built with earth reinforcement system made of steel. The avalanche defences were inducted in 2002.

The design avalanche had a return period of 1000 years with a 3 metre thick dense core, a speed of 38 m/s, and thus a Froude number of 7 upon hitting the upper row of mounds. The shallow-layer theory predicts that a dam with an effective height of 32 metre is needed such that a shock will form upstream of the mounds. The theory therefore predicts that the flow will be launched in a supercritical flow state over the mounds. Parts of the avalanche will be deflected between the mounds, also in a supercritical flow state. The two rows of mounds were therefore spaced such that an avalanche could be launched ballistically over the first row of mounds and would land upstream of the lower row and of the catching dam downstream of the mounds. With this design it is guaranteed that both rows of braking mounds will effectively participate in dissipating energy from the avalanche before it hits the downstream catching dam.

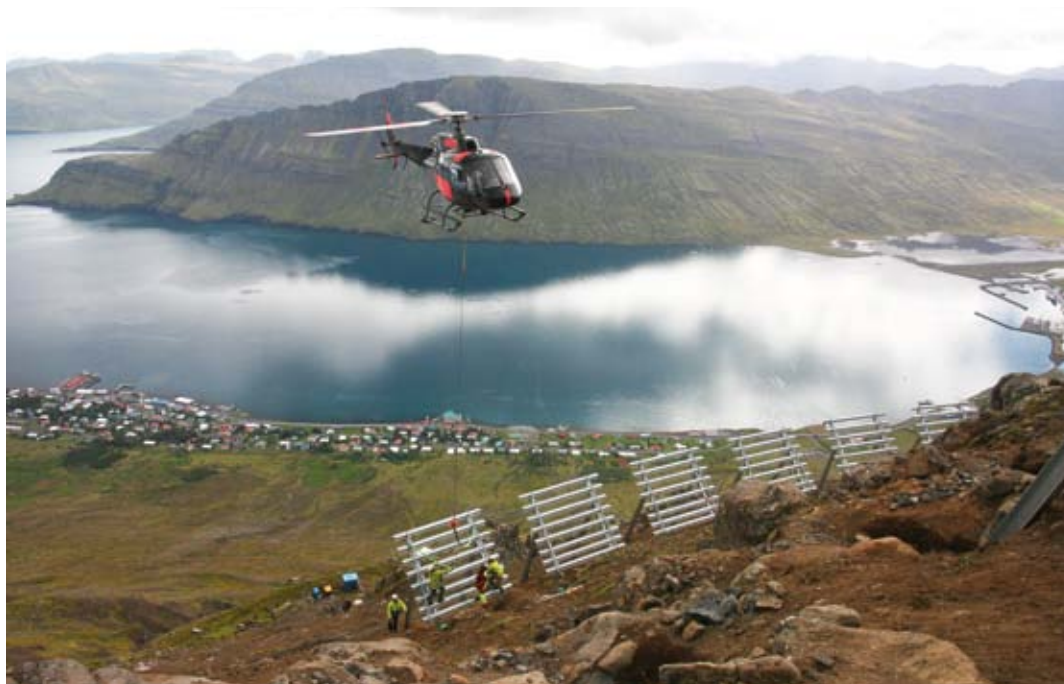
Fig. 11: Steel bridges under construction at the Tröllagil starting zone (Copyright Mair Wilfried GmbH)

galvanised for Icelandic conditions. Varying the distance of the bars and using uniform dimensions has the advantage of lower weights (up to 169 kg or 22% for DK 4.5).

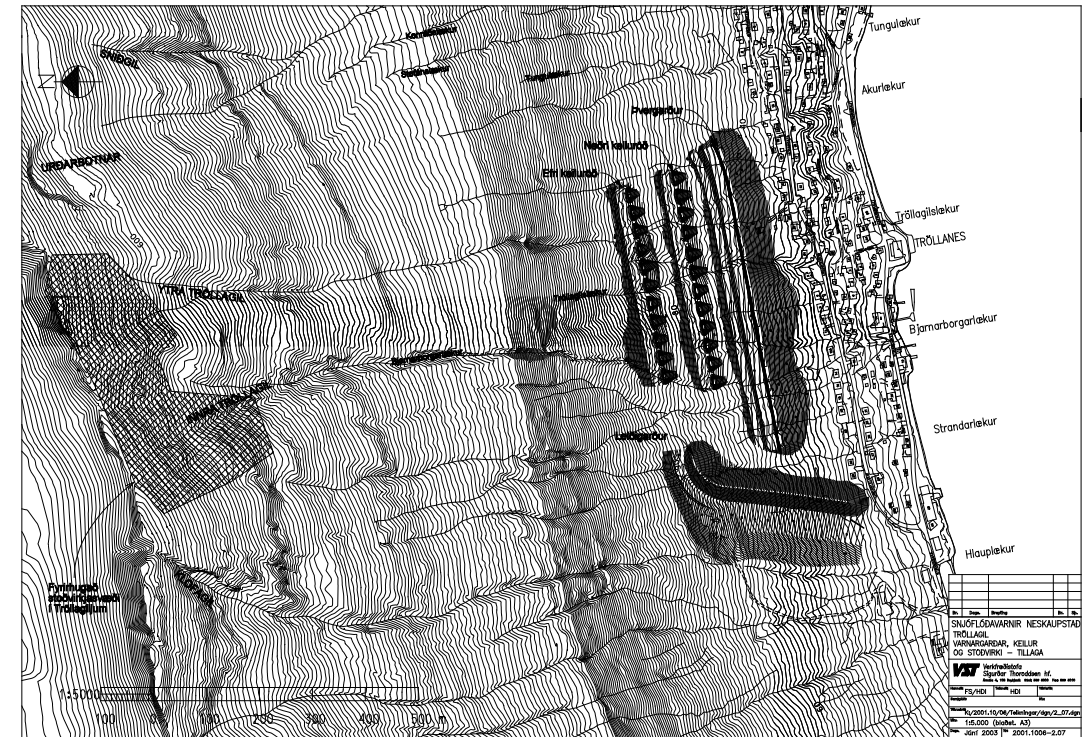
Fig. 12: Overview of the planned measurements in Tröllagil

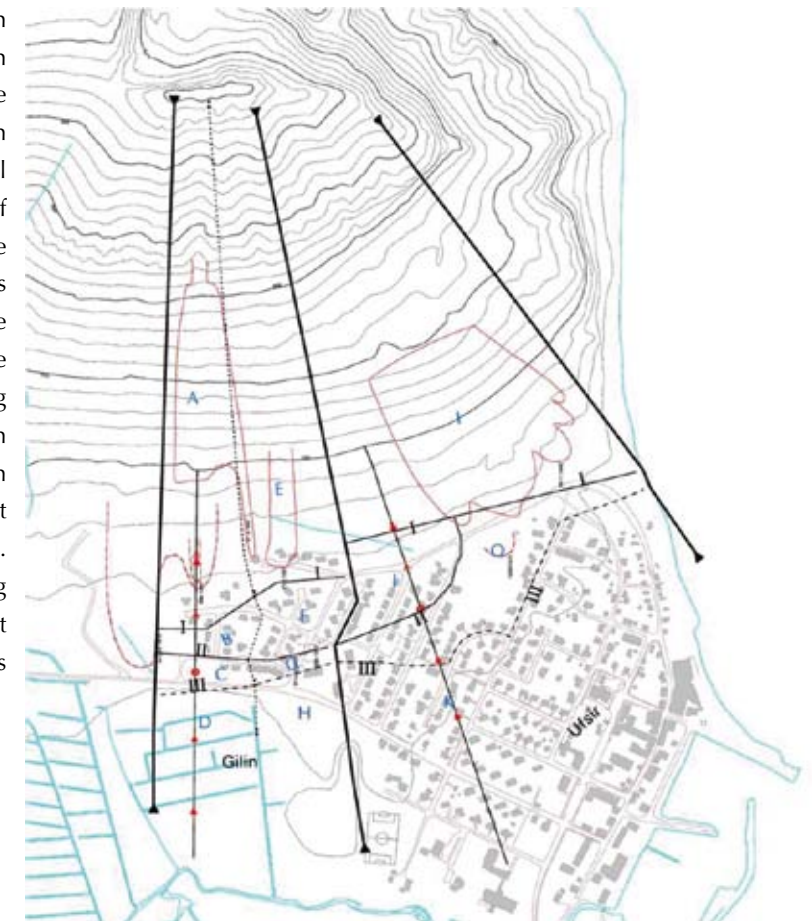
Fig. 14: Evacuation plan Bolungarvik

The evacuation plans are made in collaboration with the civil defence division of the National Commissioner of the Icelandic Police in Reykjavík. Plans are executed by the local civil defence authorities according to an evacuation map with evacuation areas on different levels (I, II and III). An accompanying report from IMO about avalanche conditions is added.

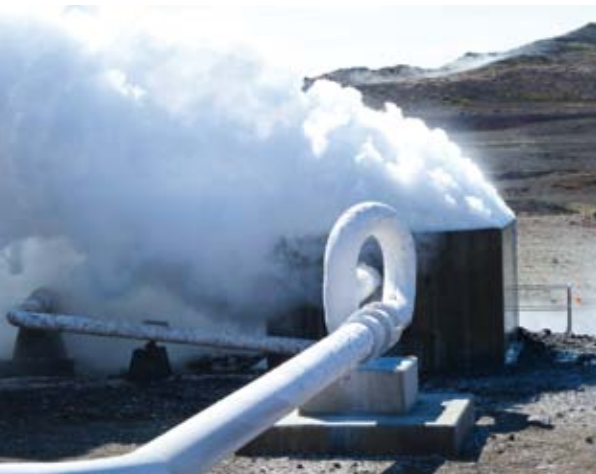
Fig. 12: Production well of Krafla geothermal power plant

In 1996, the second turbine was installed and new boreholes were drilled. Electricity production using the second turbine unit began in November 1997 and Krafla Station has been operating at its full installed capacity of 60 MW since 1999.

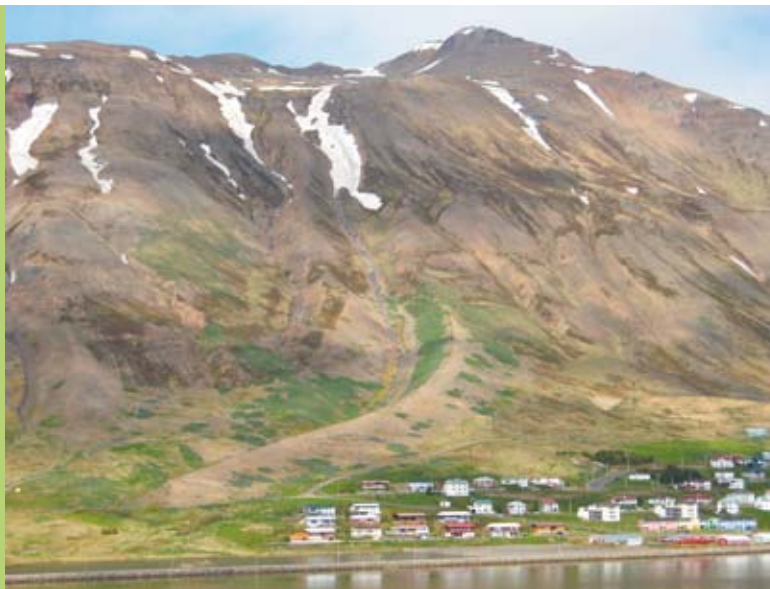
dams were built to protect the settlement. The dimensions of the big deflection dam (Stori boli (big bull)) are 700 metres in length with a height of 18 metres. The smaller one (Litli-boli (little bull)) is 200 metres long and 15 metres high.

Fig. 1:
The Strengsgili and the Jorundarskal avalanche deflection dams in the southern end of Siglufjörður

During the winter 1998/99 and after finishing the construction in 1999, several avalanche events happened and the avalanches were successfully deflected as designed.

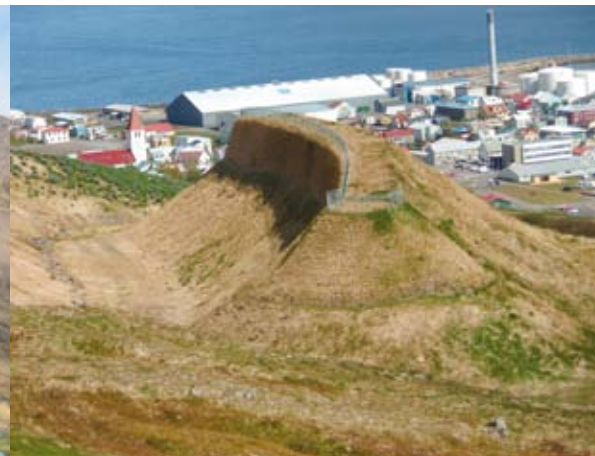
Fig 3: Avalanche catching dam above the town with a viewpoint

settlement (see Fig. 2). From the southern to the northern end of the town, 5 catching dams were constructed with earthworks and strengthened geo textiles. At the northern end of Siglufjörður another deflection dam protects the houses now.

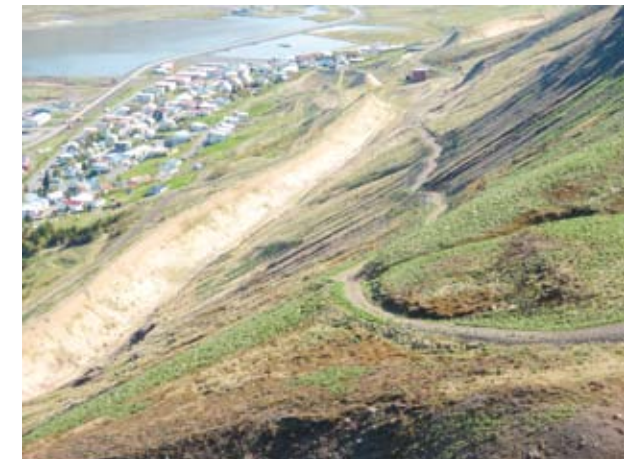
Fig 4: The longest avalanche catching dam in Siglufjörður

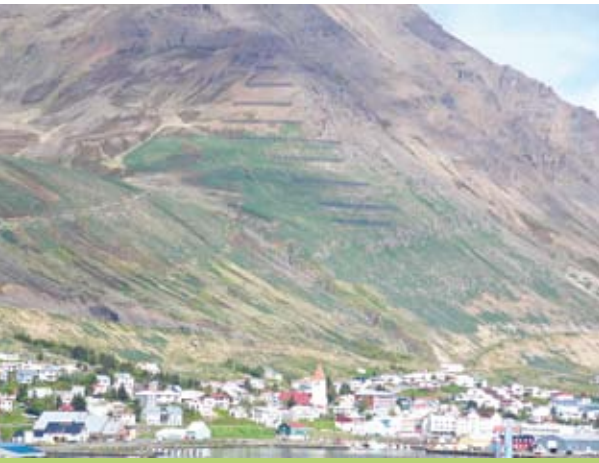
In the north of Siglufjörður, the avalanche path from Grouskardshnjukur endangers the settlement area of Hvanneyrarkrokur. To improve the safety of people it was decided to combine a catching dam near the houses with about 620 metres of supporting structures in the main release zone. The starting zone begins at 300 metres above sea level and ends at a height lower than 150 metres above sea level.

Fig. 5: Avalanche path north of Siglufjörður

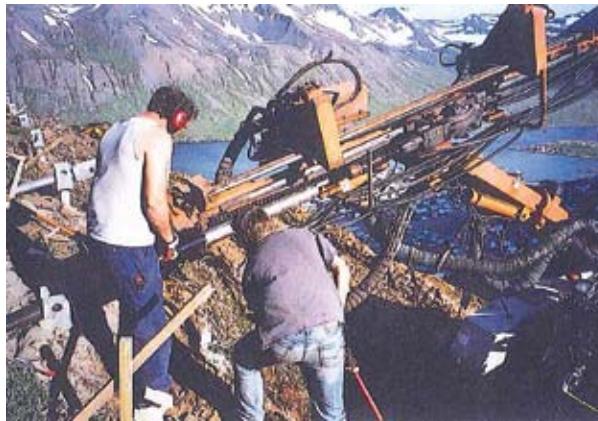
Fig. 6: Drilling the upper anchor

anchor to prevent heavy storms from lifting the footplate. Footplates are covered with loose material for the same effect. The length of the upper anchor is about 5 metres to 6 metres.

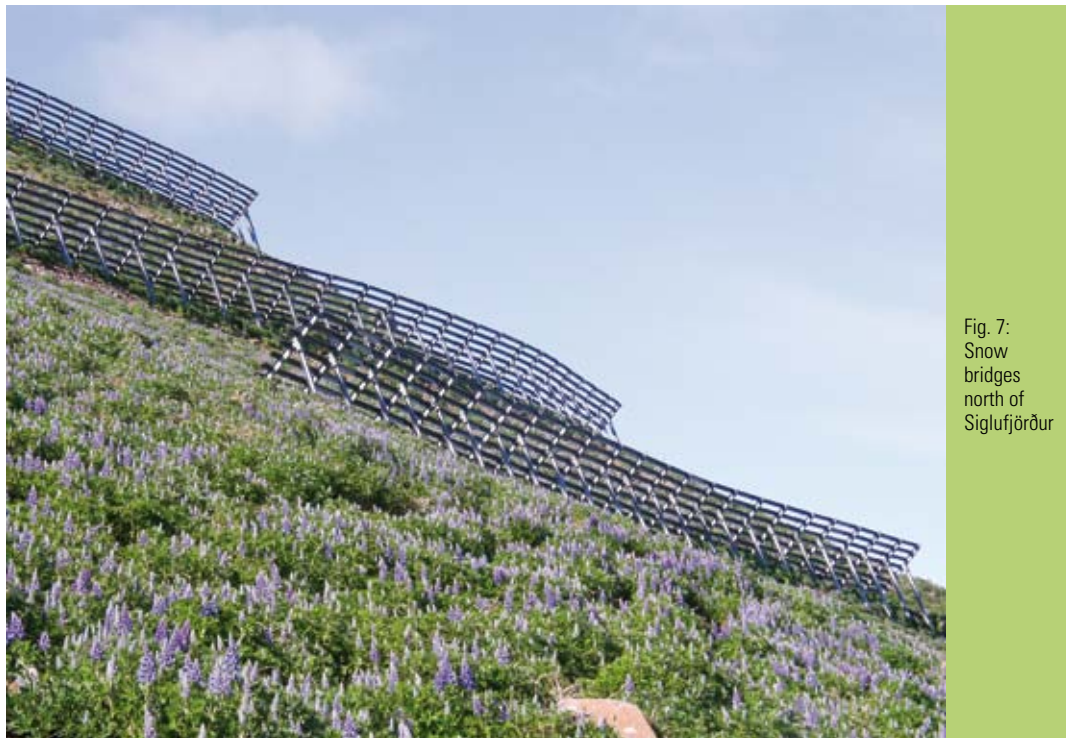
Fig. 7:
Snow
bridges
north of
Siglufjörður

Based on the experiences made at the pilot project in Grindagil, it appeared feasible to use snow bridges to stabilize the snowpack in the steep slope. This type of construction has greater reserve strength to withstand overloading and has no problems with corrosion under Icelandic meteorological conditions. The snow bridges at Siglufjörður

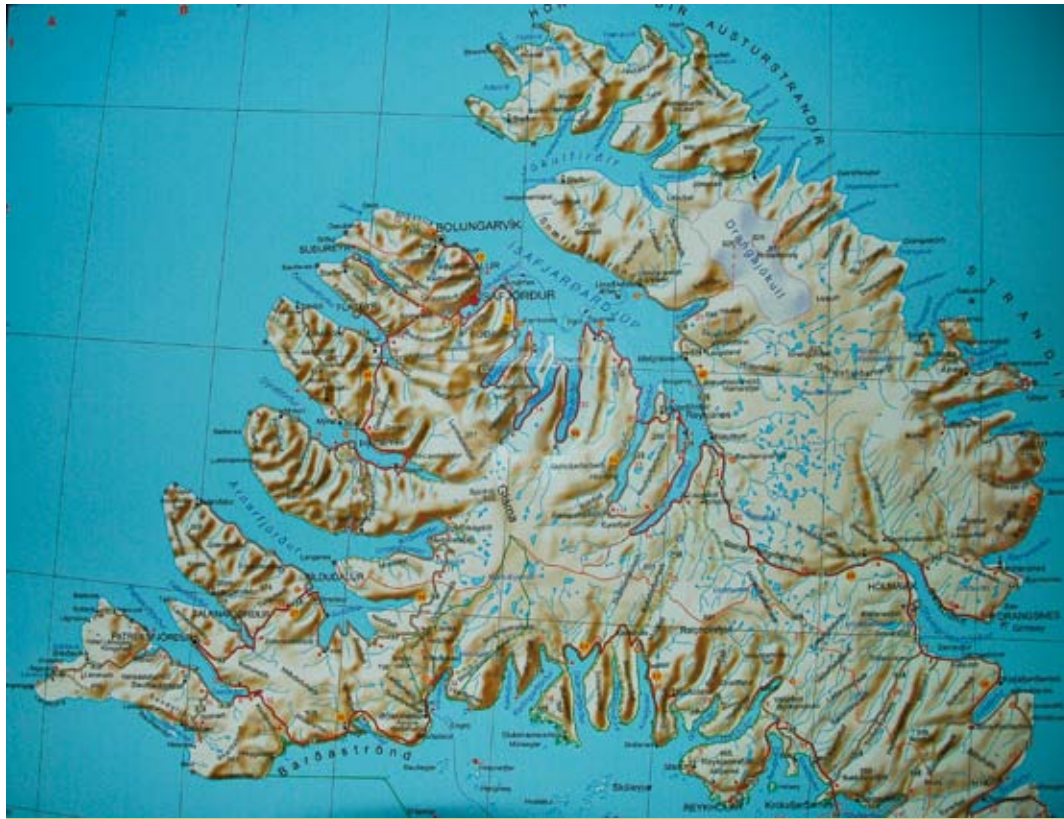
Fig.1: General map of the Westfjords, containing the villages Ísafjörður, Hnífsdalur, Bolungarvík and Flateyri

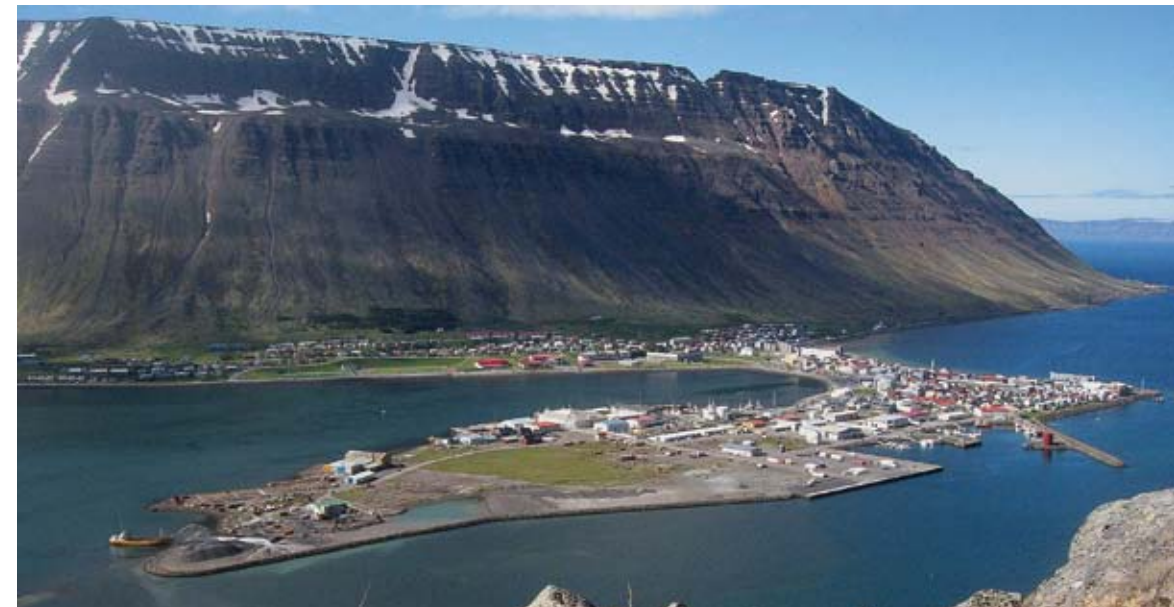
Fig. 6: Ísafjörður with threatening, south-east facing slopes towering above the town centre, where previously no major avalanches had been observed.

slopes. But a sword of Damocles hangs over the inhabitants here as well: The 700 ha large slopes are only interrupted by around 150-200 metre wide flat area at 450 metres above sea-level before they break steeply down over 380-400 ha to the densely populated coast. Due to the winds mainly coming from the north and north-east and blowing parallel across these slopes, the centre of Ísafjörður has been spared from larger avalanche events in the recent past.

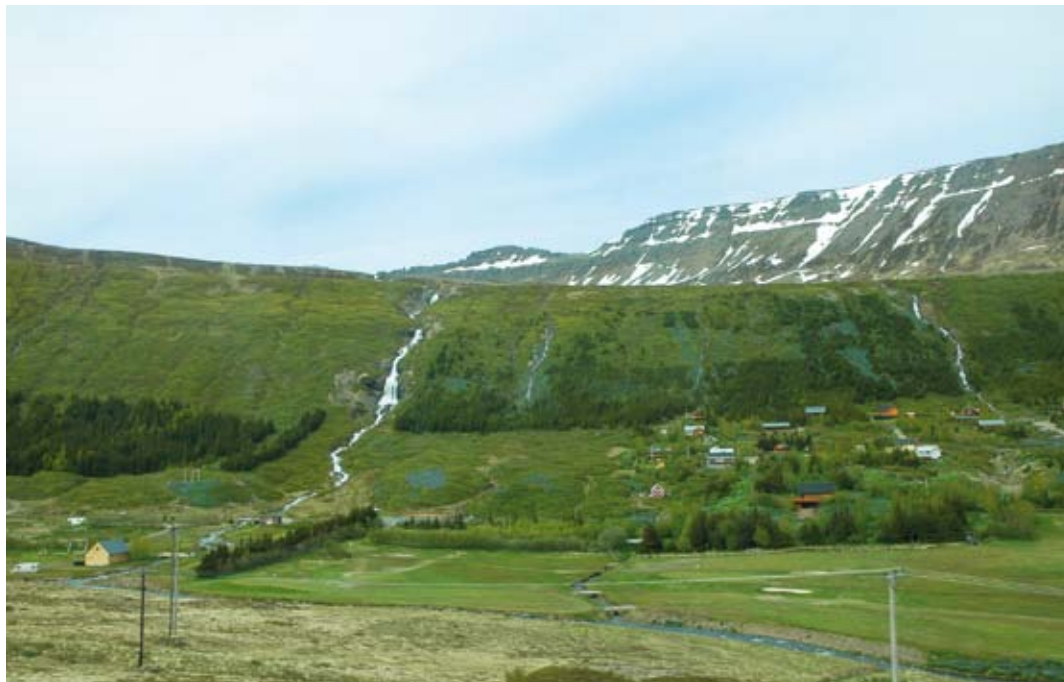
Fig. 7: South to south-west facing slopes above Ísafjörður, where large avalanches penetrated over a flattened slope into the valley.

large avalanches followed on the south slopes in the years 1994 (figure 7 and figure 8) as well as 1999 and 2005.

The red avalanche danger zone (C-Zone) was placed above the scattered settlement within the deposit limits of the major avalanches (Figure 7).

No construction or braking measures have yet been taken for the areas affected by the event on April 5, 1994. A guard wall should be able to deflect the avalanche to the west but also have openings for several mountain torrents (see figure 7) - therefore this would not be easy to implement. Furthermore, the relevant break off areas for this area are again under a larger summit plateaus which would increase the vulnerability of this type of dam project.

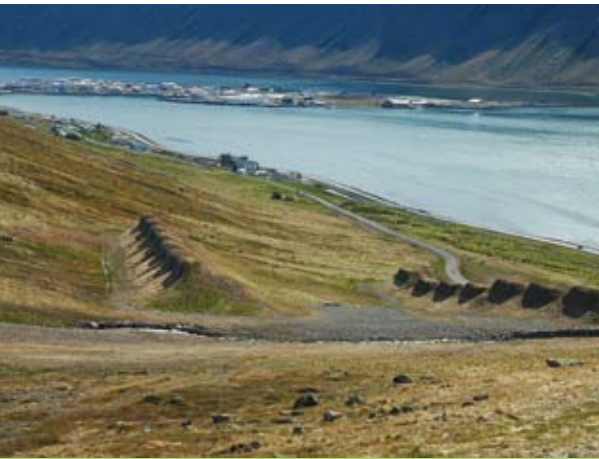
Fig. 9: Ísafjörður: Braking elements before the avalanche deflecting dam.

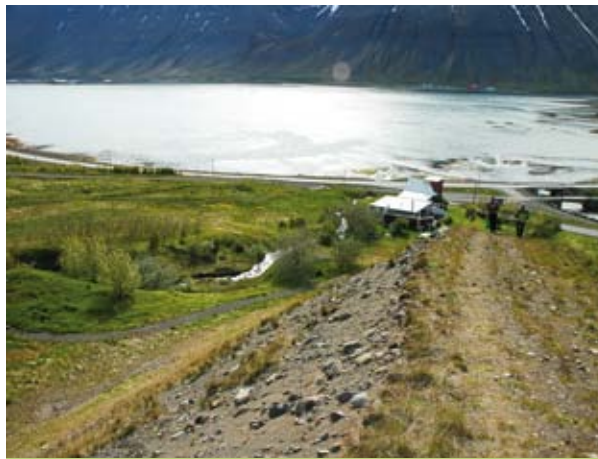
Fig. 10: Ísafjörður: The avalanche deflecting dam constructed in 2004 with a building in the middle of the run off zone.

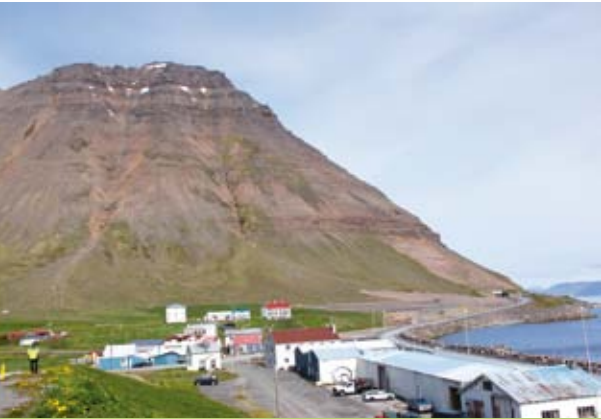
Fig. 13: Hnífsdalur: Above the settlement, contrary to the normal slope avalanches in Iceland, there are three arrow-shaped avalanche ravines.

to the standard type of Icelandic slope avalanche that are found on most slopes above the fjords, the "SAMOS" avalanche model was tested on them and the Icelandic parameters were calibrated.

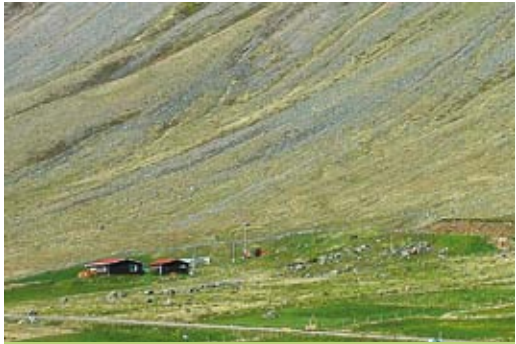
Fig. 14: Highly endangered homes with the collection of stones in the foreground that is typical for avalanche deposit zones.

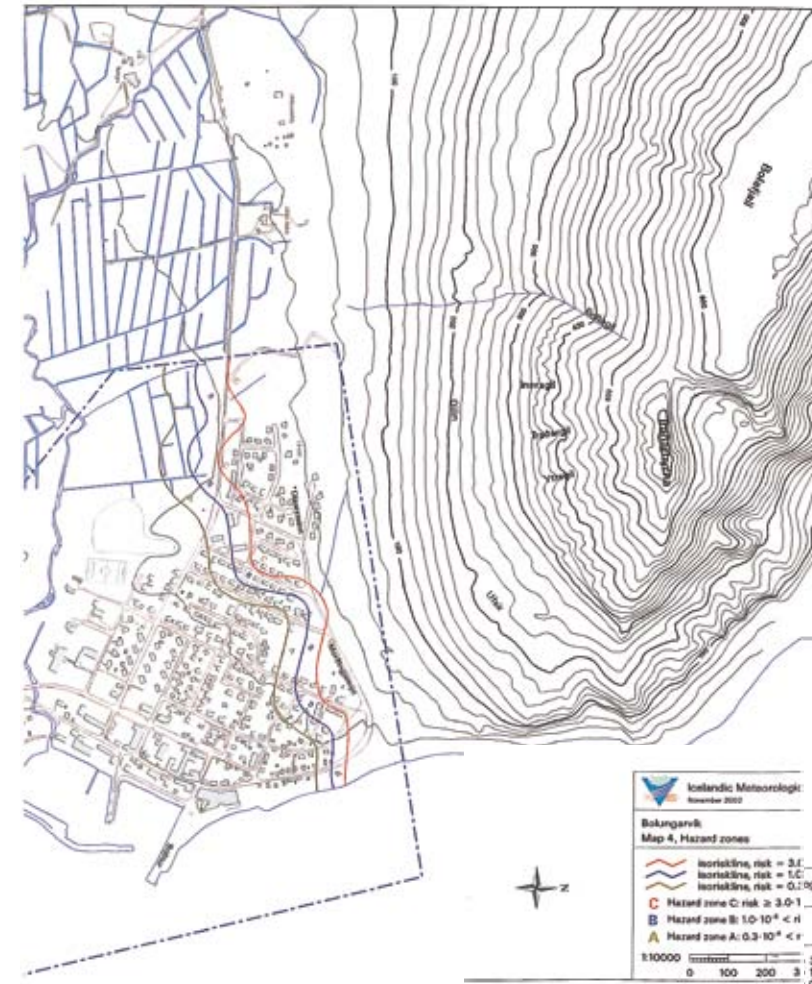
Fig. 18: Hazard-zone map for Bolungarvík.

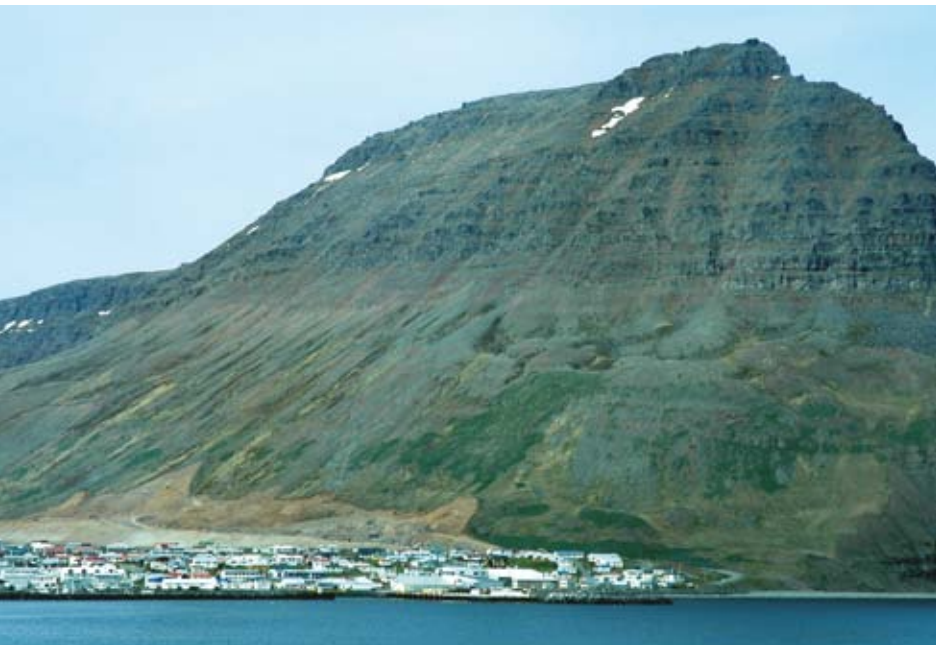
Fig. 19: Bolungarvík at the foot of the south-east facing slope on the 600 metre high Bolafjall. The current avalanche dam construction site can be seen in the photo.

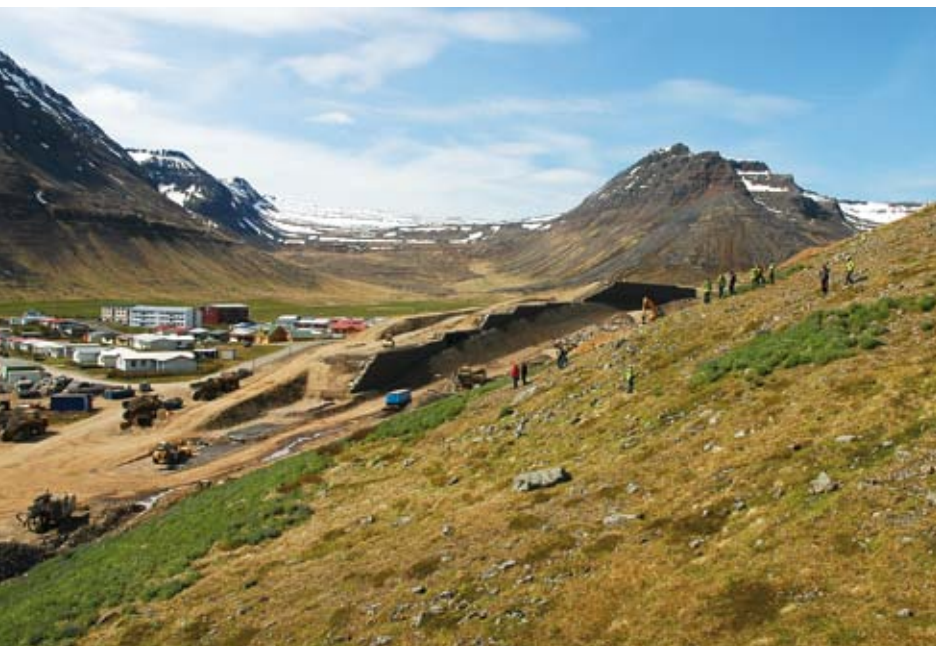
Fig. 20: Bolungarvík construction site: Construction of a 22 metre high avalanche catchment dam

- Material requirements of 400.000 m³ for the main dam (w = 52, h = 22, l = 700 linear metres)
- with expected installation costs between 12 and 15 €/m³

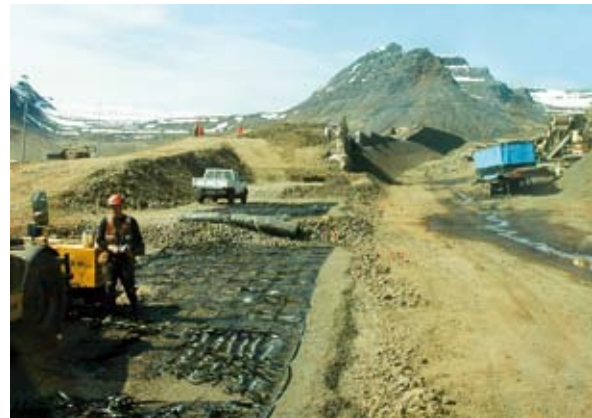
Fig. 21: Compactors (left), reinforced earth and stone crushers (right) during the processing of the autochthonous material.

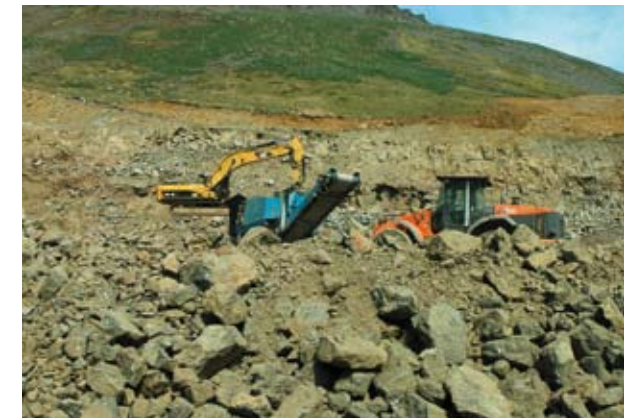
Fig. 22: Well-organized use of heavy equipment on the 700 linear metre long dam construction.

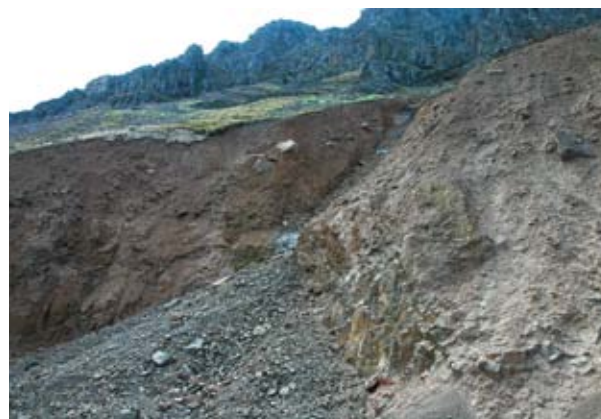
Fig. 27: Glacier layers and slope rubble bodies thoughtlessly cut during road construction in the 60s.

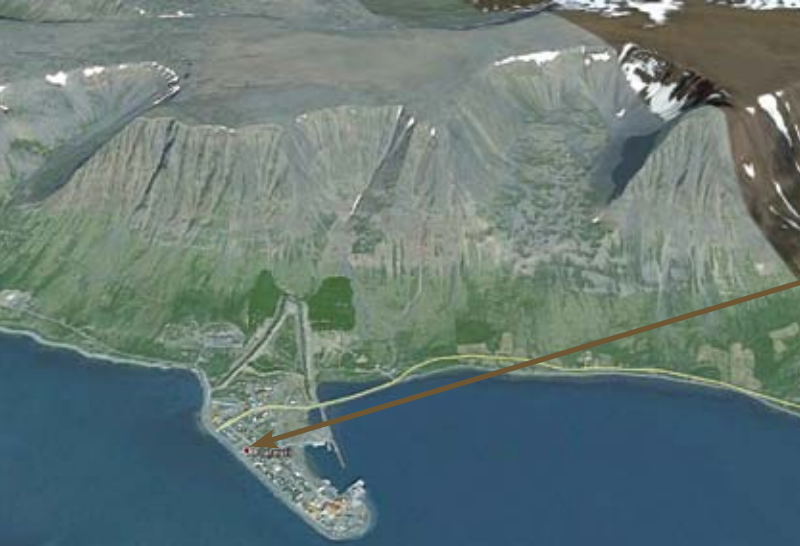
Fig. 30: Flateyri, at the foot of a 660 metre high mesa with a large summit plateau.

Above Flateyri there is a 660 metre high mesa with a 1.2 km wide summit plateau, a rich breeding ground for avalanches. The hitches are oriented to the south west, which is extremely unfavourable for the Icelandic situation and the predominant north-east weather conditions. Two break

basins and the hitches located underneath them point exactly to the settled headland on which the settlement was founded.

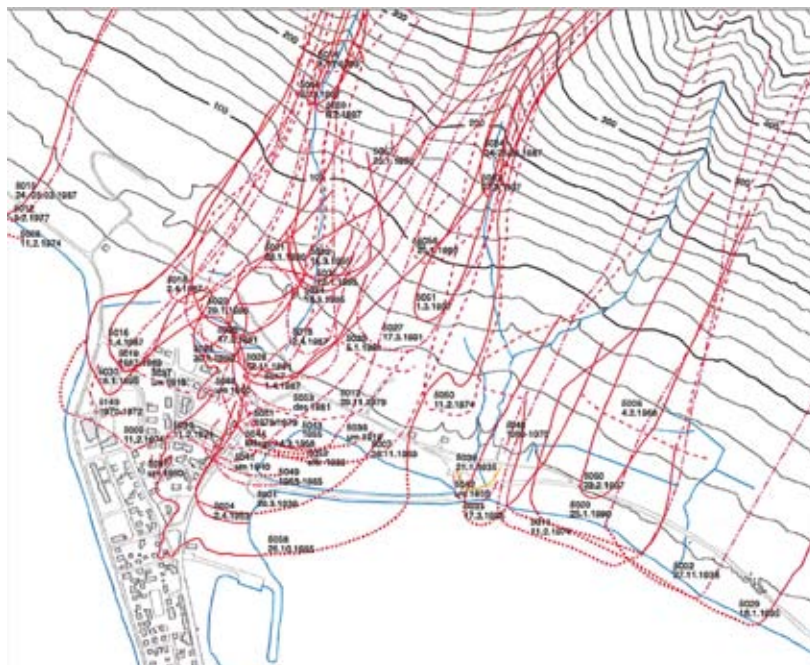
Fig. 32: Mapped avalanche run outs in the Flateyri settlement.

1963, 1972, 1974 in as in January 1995, which almost reached the existing settlements, on October 26 (!) after three days of snow accompanied by a strong wind that reached speeds of 160 km/h in the night before the avalanche, a catastrophic avalanche happened at 6:15. 430,000 m³ snow broke off of the east of the two basins; Off shoots of the avalanche penetrated deep into the headland, burying 32 homes and 54 people. Twenty people

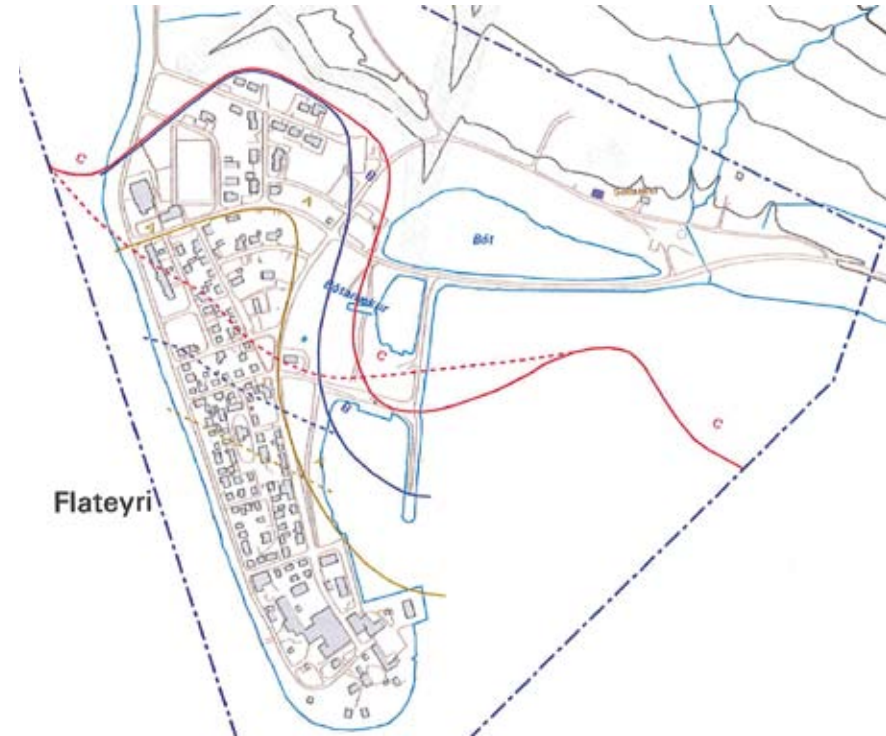
Fig. 33: Hazard-zone map for Flateyri including the protective effect of the A-shaped dams built in 1995.

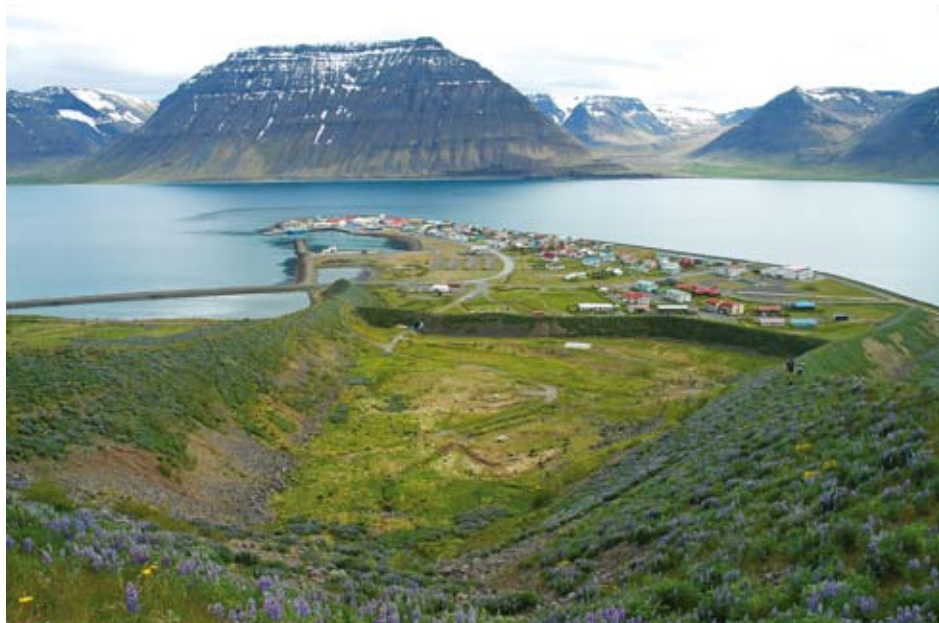
Fig. 36:
The guide dam
and the avalanche
barrier
from a
bird's eye
view.

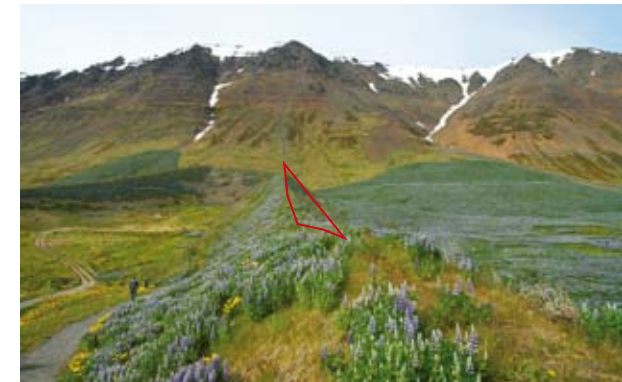
Fig. 38: A weak point crest of the guard wall.

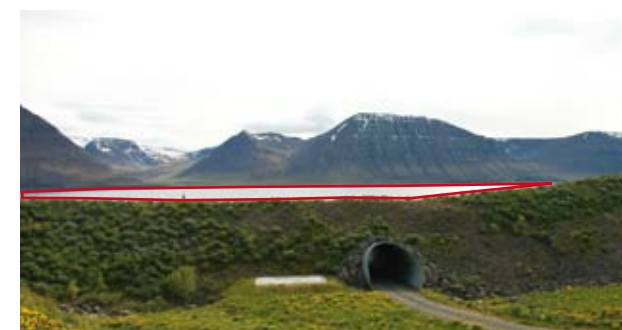
Fig. 39: A weak point in the catching dam – probability due to a culvert that was too short; the sea level clarifies the horizontal levels

The crown of the eastern deflecting dam appears to be a bit too deep at the critical collision location (Figure 38); this is also true for the crown of the avalanche barrier (Figure 39).

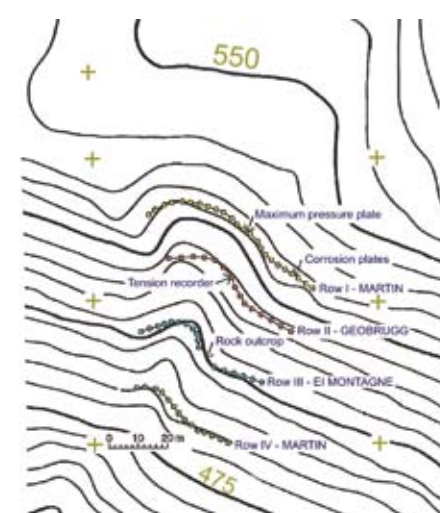
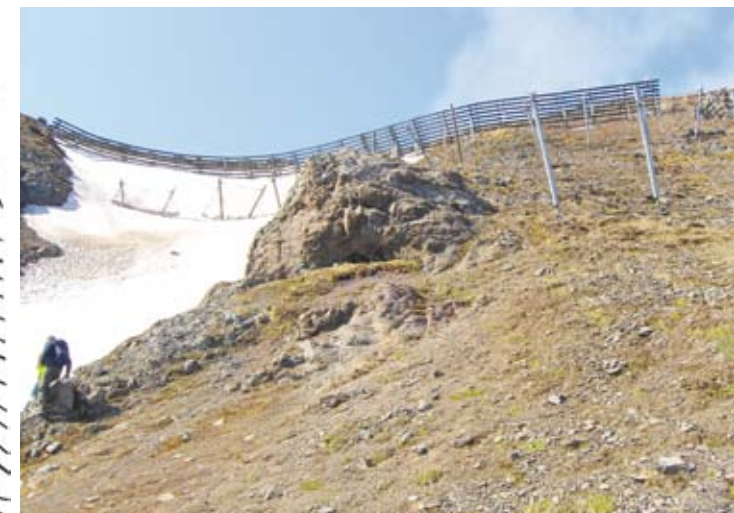
Fig. 1: Location map of the supporting structures in Siglufjörður showing the location of the upper anchors in each row together with the placement of measuring instruments in the rows.

The supporting structures of Siglufjörður are located at 490-530 metres above sea level. The structures are arranged in four rows which are labeled I, II, III and IV from above (Figure 1). The types of structures in each row are given in Table 1:

Row	Type	Producer	Length (m)	Number of posts	Height Dk (m)	Cost (kIKR/m)
I and IV	bridges	J. Martin	110	38=24+14	3-5	161
II	nets	Geobrug	50	14	3-4	156
III	nets	El Montagne	41.5	15	3-5	158

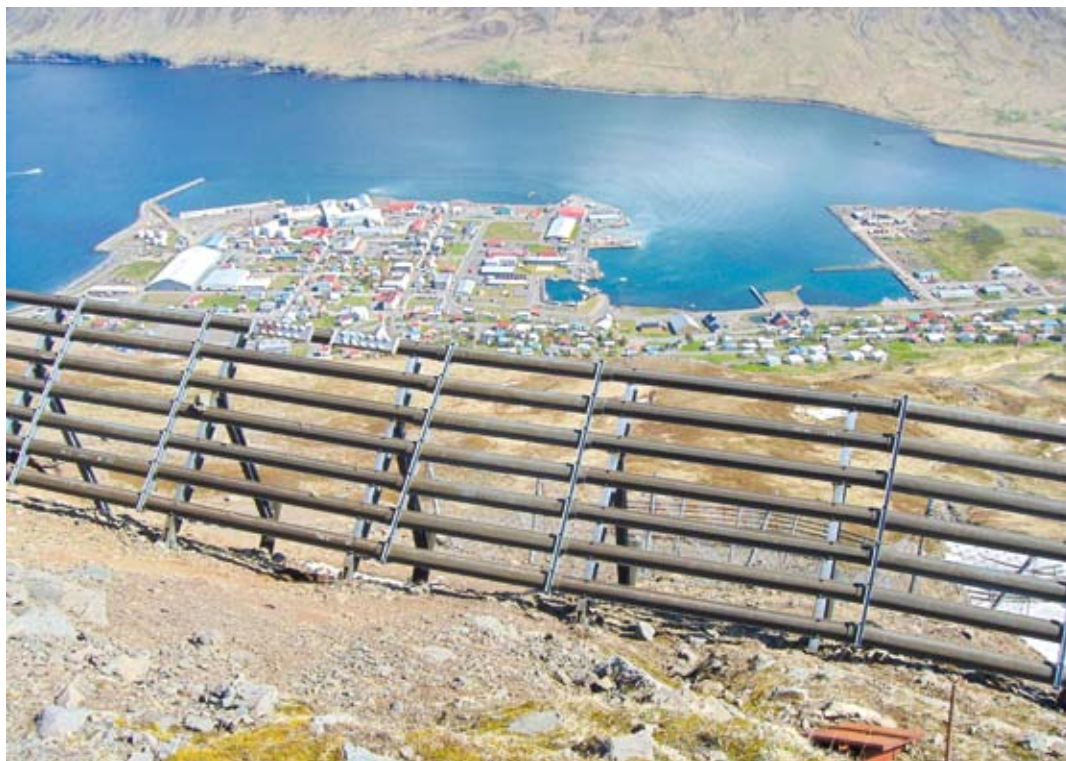
Fig. 2: Uppermost row of J. Martin snow bridges. The line is adapted to the curved terrain. Plates for measuring maximum snow pressure are seen on the left side.

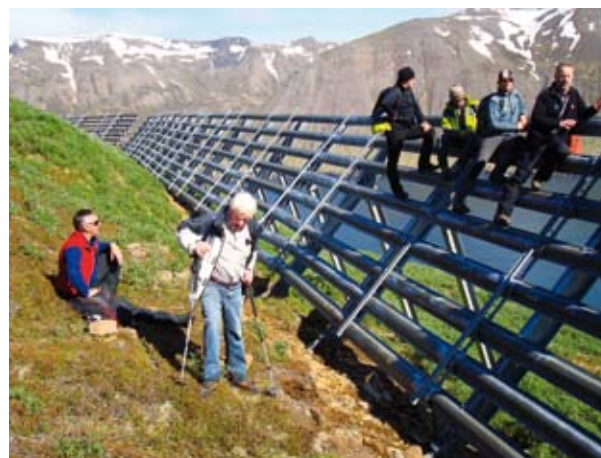
Fig. 3: The snow bridges are designed for snow heights up to 7 metres

corresponds to a vertical snow depth of more than 7 metres (Fig. 3). This part of the row has been overfilled several times by up to more than 2 metres (!) without this leading to any detectable damage of the structures. Figure 4 (left) shows

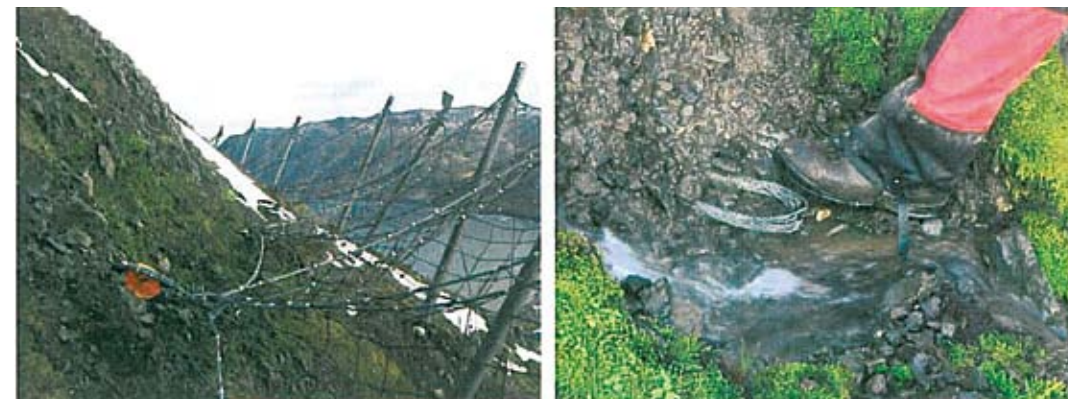
Fig. 4: An instrument for measuring tension in the Geobrug net row (left) and a broken top loop in a wire rope anchor from the same row (right).
