Wildbach- und Lawinenverbau

Zeitschrift für Wildbach-, Lawinen-, Erosions- und Steinschlagschutz
Journal of Torrent, Avalanche, Landslide and Rock Fall Engineering

Study trip 2011 Iceland

ISBN: 978-3-9503089-2-1
75. Jahrgang, Dezember 2011, Heft Nr. 168

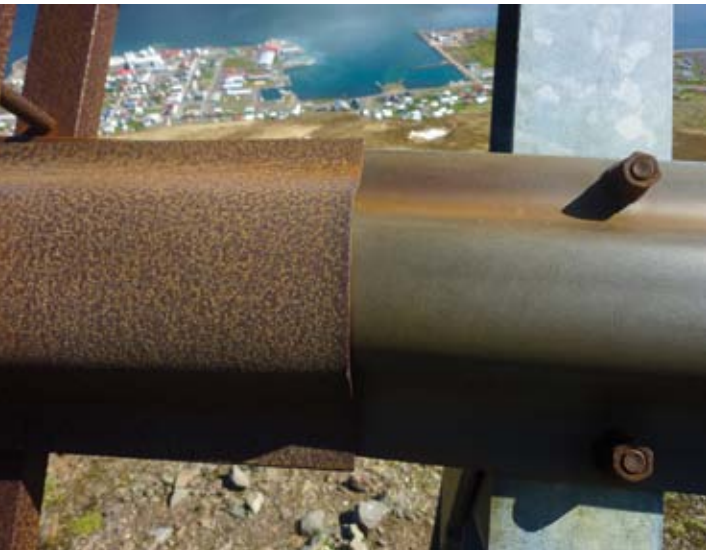
Fig. 7: Comparison of galvanized and black type of snow bridges in the lowest row of the J. Martin snow bridges (left). The row with EI snow nets was deformed by the heavy snow loads, partly due to lack of lateral stability.

hot-dip galvanised for Icelandic conditions. The experience in the test area indicates that, with that type of protection, corrosion is not a problem for steel bridges.

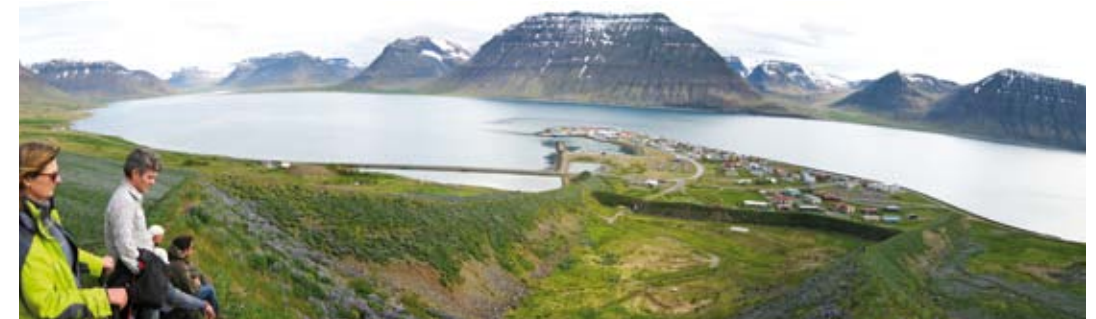
Fig. 3: Flateyri in 2011, with the two big deflecting dams and the catching dam in the background.

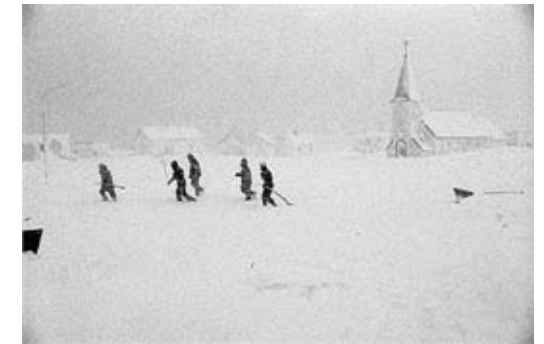
Fig. 2: On October 26, 1995 an avalanche from Skollahvilt pushed far into the residential area where 29 houses were damaged or destroyed and 20 people killed. The church was not damaged.

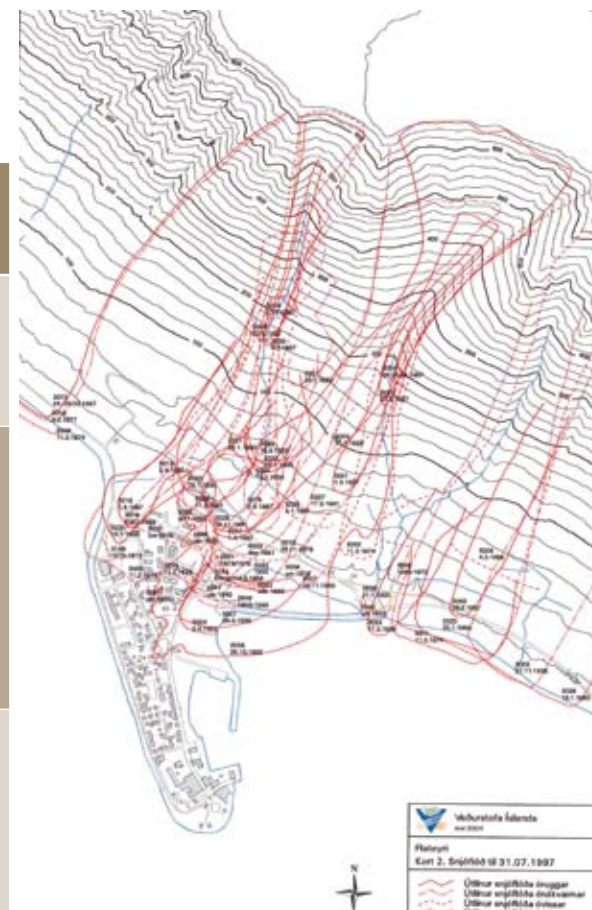
Fig. 4: Several recorded avalanches from Flateyri and their dates (solid line: certain, dashed-and-dotted line: inaccurate, dashed line: unknown, dotted line: sea).

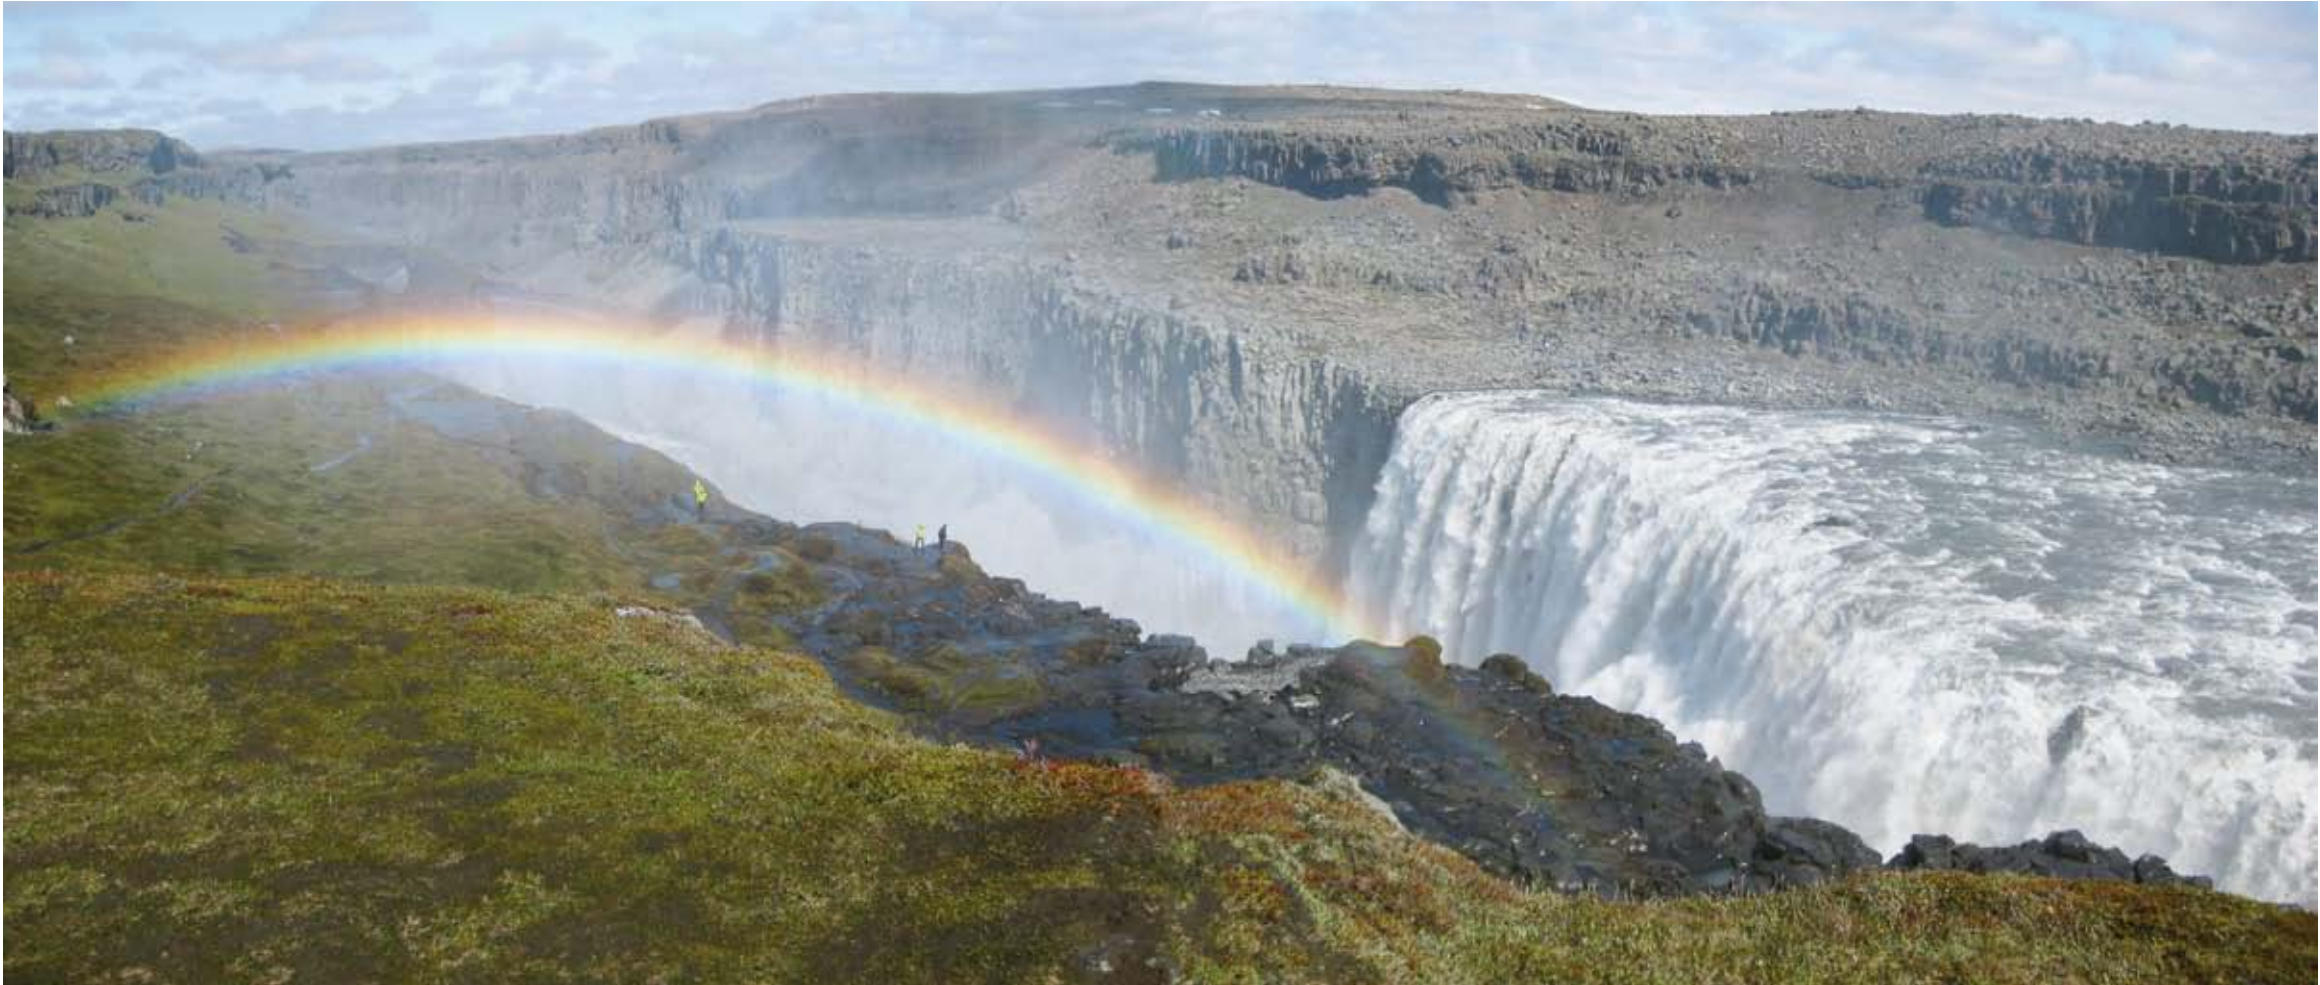
Fig. 02: Dettifoss – one of Iceland's biggest waterfalls on the glacial river Jökulsá á Fjöllum originated in the Vatnajökull glacier. The average discharge rate is $183 \text{ m}^3/\text{sec}$ while the discharge during summer times is up to $1500 \text{ m}^3/\text{sec}$ transporting $120,000 \text{ m}^3$ of bedload every day.

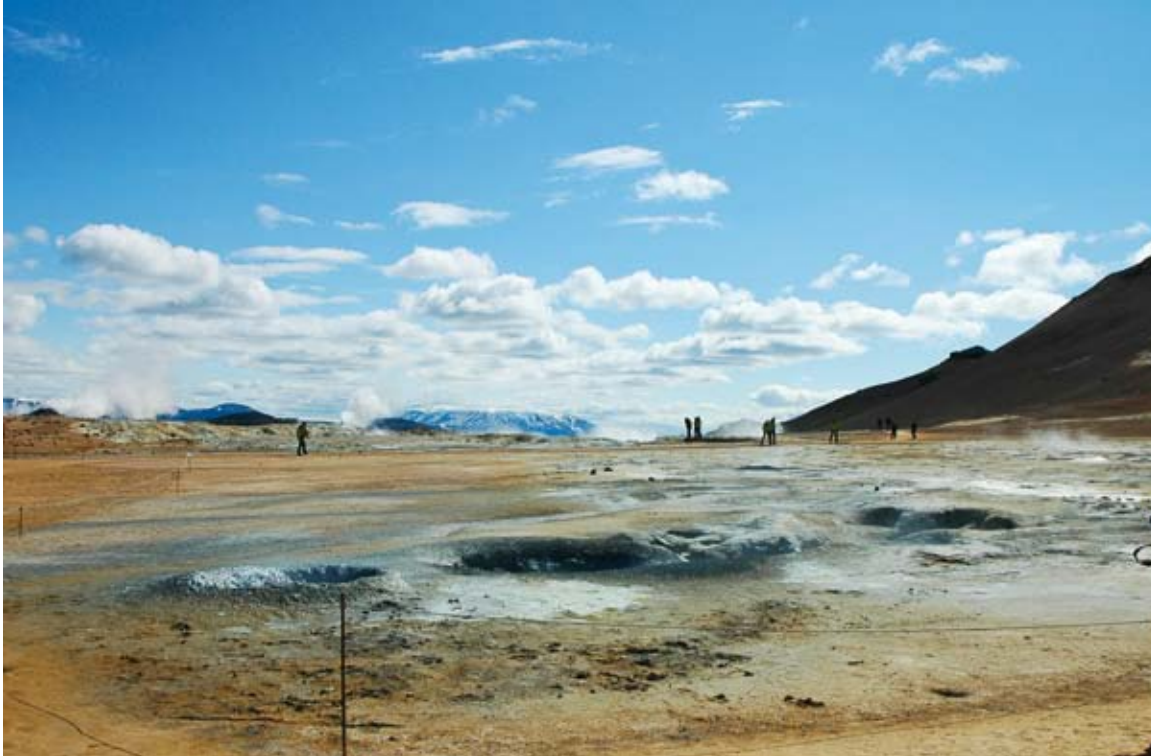
Fig. 03: Geothermal area at Mt. Namafjall called Hverarönd. Groundwater seeps down to a depth of 1000 metres where its temperature rises up to 200°C and find its way upward as hot steam. Along with the steam come volcanic gases such as hydrogen sulfide which is responsible for the characteristic smell.

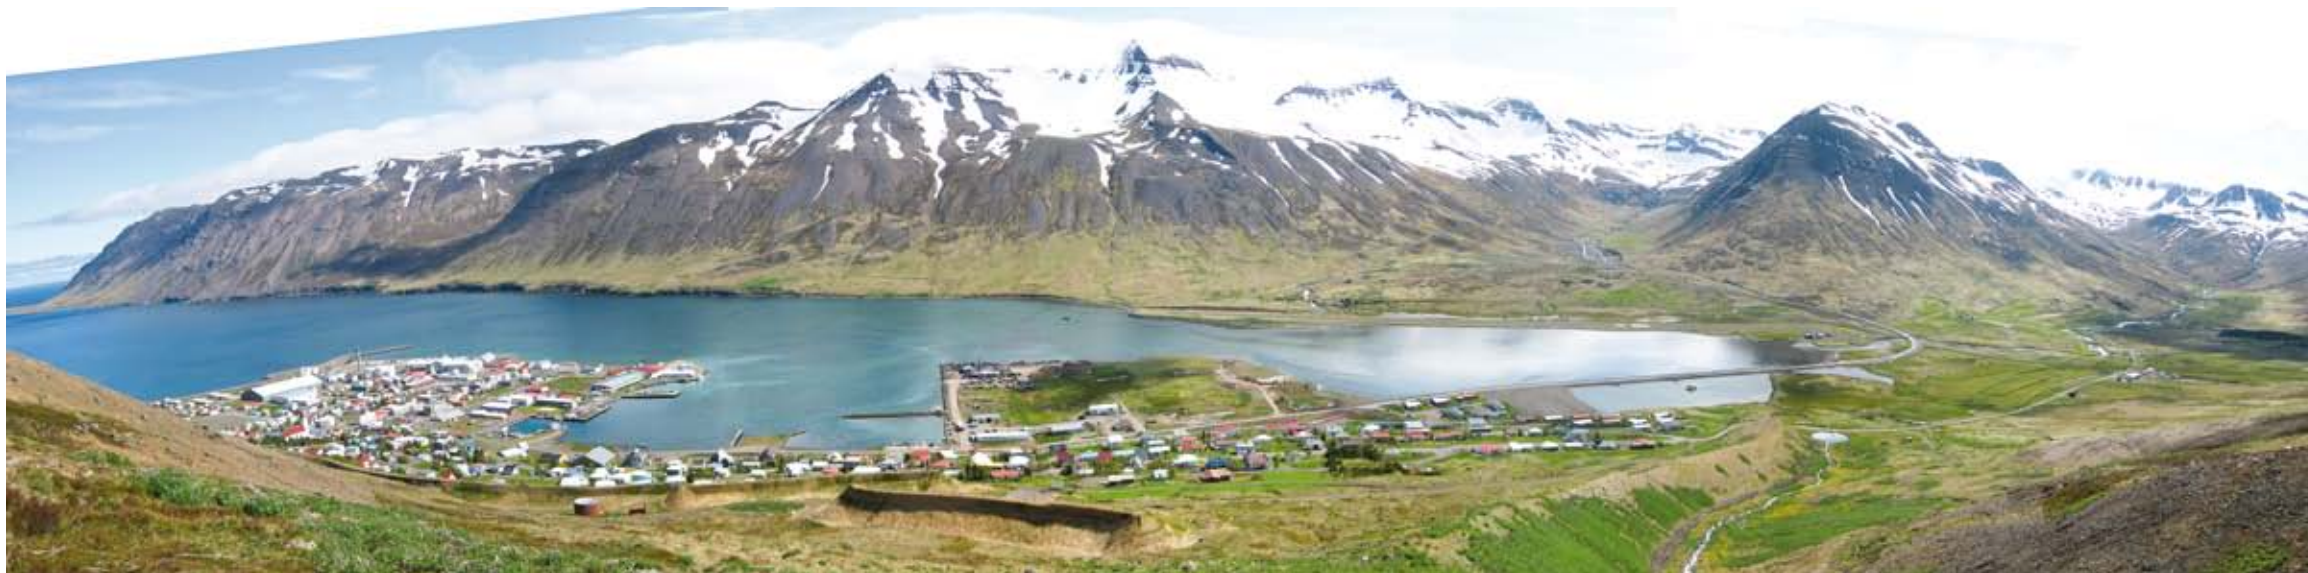
Fig. 05: Deflection and catching dams above the settlements in Siglufjörður in front of the panoramic view. In 1996 a testing area was established in the mountains above Siglufjörður to carry out the feasibility of supporting structures for avalanche protection under Icelandic conditions.

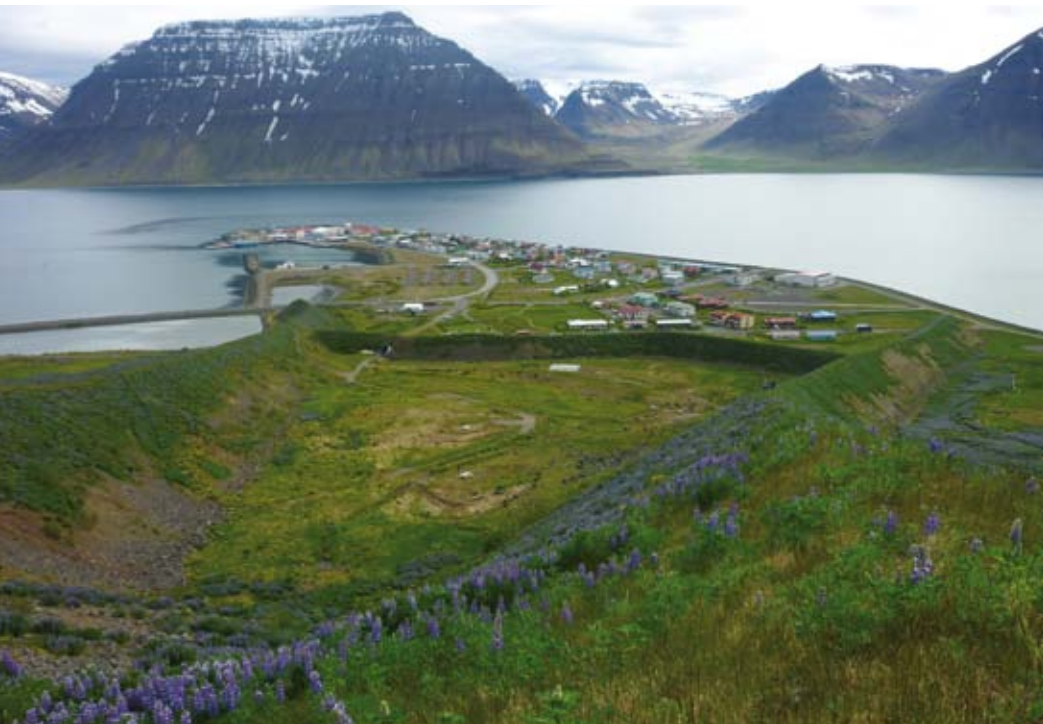
Fig. 11:
On October 26, 1995 a big avalanche killed 20 people in the community of Flateyri in the Westfjords. An A-shaped combination of two 15-20 metre high deflecting dams and one app. 10 metre high catching-dam was built in 1996-1998. These were the first of their kind in Iceland and was considered to be very large even on a global scale.

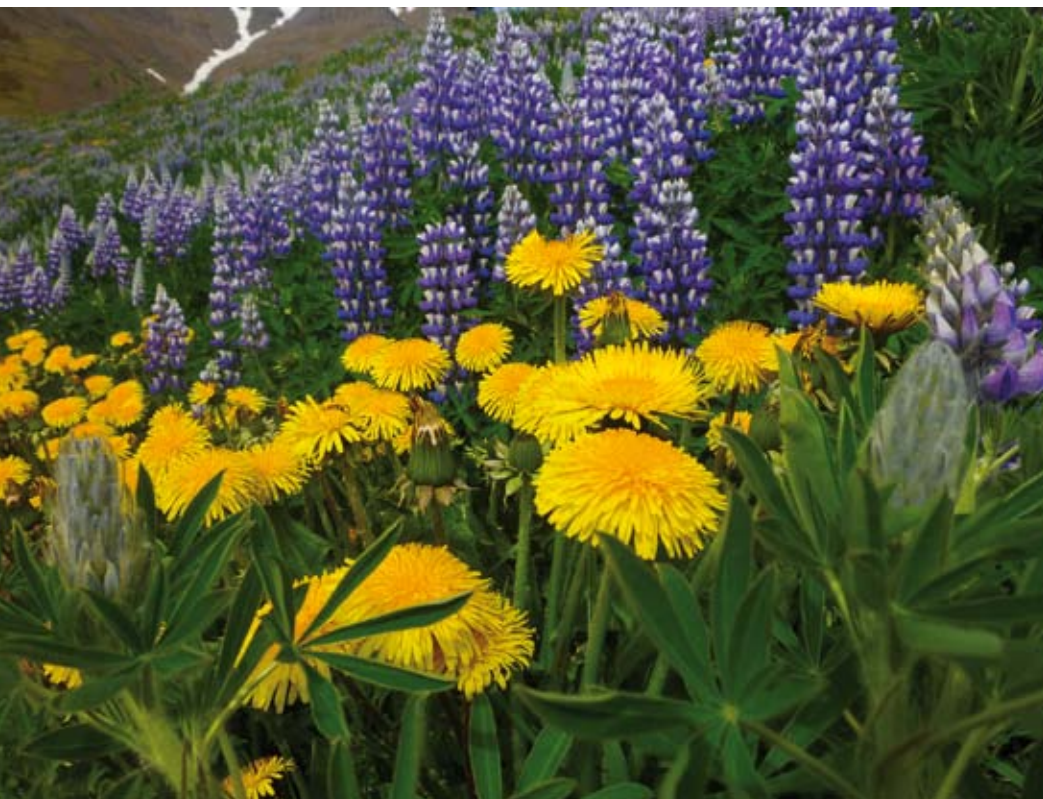
Fig. 12:
Lupine together with hawkbit nowadays covers most of the areas affected by supporting structures or avalanche dams and therefore reduces soil-erosion significantly.
